**GUIDE**  
**FOR**  
**SELECTING ROUGHNESS COEFFICIENT**  
**"n" VALUES FOR CHANNELS**

Compiled by  
Guy B. Fasken, Drainage Engineer  
SOIL CONSERVATION SERVICE - U. S. D. A.  
Lincoln, Nebraska 68508  
December 1963

The purpose of this group of pictures, selected from Technical Bulletin No. 129, "Flow of Water in Drainage Channels" by C. E. Ramser, is to illustrate the wide range of the roughness coefficient "n" of Manning's formula for channel velocities related to actual channel conditions. Study of the pictures and information shown should assist in selecting realistic values of "n" for both present and future constructed channels.

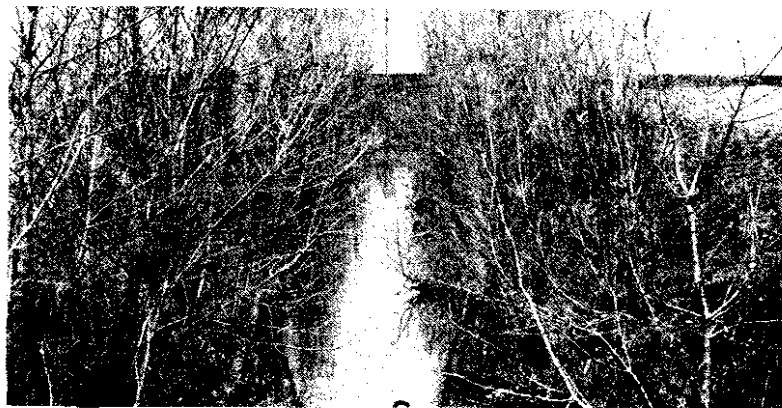
Kaskaskia Mutual Dredged Channel near Bondville, Illinois. Approximate bottom width 10 feet. Picture taken April 1925.

Date of observation	Average maximum depth	Average surface width	Discharge	Average cross section	Mean velocity	Mean hydraulic radius	Slope of water surface	Coefficient of roughness $n$	Description of channel
Feb. 7, 1925	2.1	16.5	21.9	24.6	0.89	1.36	0.000473	0.040	<i>Course</i> , straight; 330 feet long. <i>Cross section</i> , some variation in shape; for variation in size, see Figure 20, G. <i>Side slopes</i> , rather irregular. <i>Bottom</i> , rather irregular. <i>Soil</i> , lower part, black clay; upper part, dark-gray silty clay loam. <i>Condition</i> , badly obstructed by trees 1 to 6 inches in diameter on side slopes and edges of bottom; some weeds but practically no grass; no foliage. <i>Constructed</i> , 1902; cleared, about 1910. (Pl. 27, C and fig. 19, G.)
Mar. 16, 1925	3.0	18.9	45.5	39.6	1.15	1.89	.000424	.039	
Mar. 29, 1924	5.3	27.6	106.7	92.8	1.15	3.00	.000367	.051	
Feb. 25, 1926	5.7	29.6	100.7	105.7	.95	3.19	.000394	.067

Aug. 24, 1924	4.1	23.0	67.1	64.0	1.05	2.50	0.000494	0.056	<i>Condition</i> , as described above, but with summer foliage, and water weed on bottom along one-tenth of course.
June 6, 1924	4.4	24.1	72.2	71.9	1.00	2.66	.000409	.056	
do.	5.0	26.8	85.6	88.1	.97	2.95	.000373	.060	
Aug. 21, 1924	6.1	30.9	120.4	116.6	1.03	3.36	.000427	.067	
Aug. 20, 1924	8.4	41.0	206.1	200.3	1.03	4.35	.000536	.094

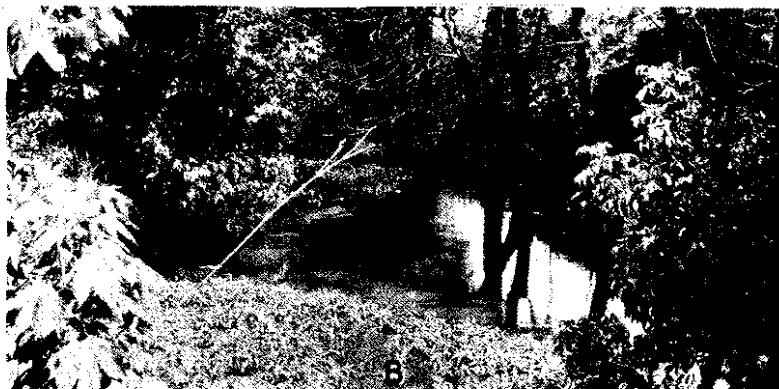
Kaskaskia Mutual Dredged Channel near Bondville, Illinois. Approximate bottom width 10 feet. Picture taken July 1927.

Date of observation	Average maximum depth	Average surface width	Discharge	Average cross section	Mean velocity	Mean hydraulic radius	Slope of water surface	Coefficient of roughness $n$	Description of channel
Sept. 28, 1926	4.3	23.8	48.0	68.8	0.70	2.58	0.000645	0.097	<i>Course</i> , nearly straight; 330 feet long. <i>Cross section</i> , some variation in shape; for variation in size, see Figure 20, F. <i>Side slopes</i> , irregular. <i>Bottom</i> , irregular. <i>Soil</i> , lower part, black clay; upper part, dark-gray silty clay loam. <i>Condition</i> , badly obstructed by trees 2 to 12 inches in diameter covering side slopes, except intervals aggregating half length of right bank occupied by large weeds and bushy willows; no foliage. <i>Constructed</i> , 1902; cleared, about 1910.
Sept. 9, 1926	7.5	34.3	111.5	137.8	.71	4.05	.000388	.110	
Oct. 2, 1926	8.0	36.6	132.3	176.4	.75	4.24	.000409	.111

*Condition*, as in summer of 1924, but worse. (Pl. 27, B.)

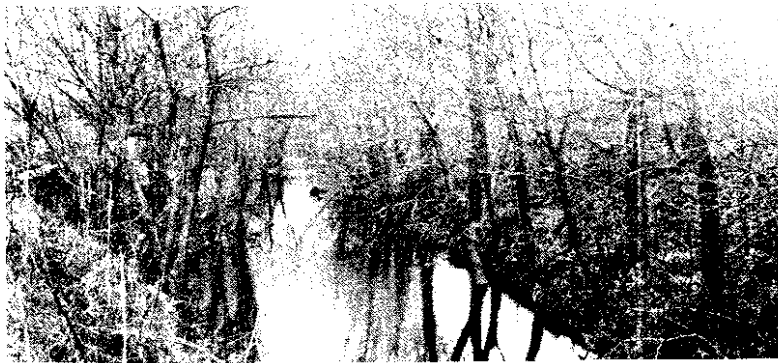
Kaskaskia Mutual Dredged Channel near Bondville, Illinois. Approximate bottom width 10 feet. Picture taken April 1925.

Date of observation	Average maximum depth	Average surface width	Discharge	Average cross section	Mean velocity	Mean hydraulic radius	Slope of water surface	Coefficient of roughness $n$	Description of channel
Feb. 7, 1925	2.4	18.1	21.9	29.8	0.73	1.50	0.000527	0.054	Course, nearly straight; 330 feet long. <i>Cross section</i> , some variation in shape; for variation in size, see Figure 20, F. <i>Side slopes</i> , irregular. <i>Bottom</i> , irregular. <i>Soil</i> , lower part, black clay; upper part, dark-gray silty clay loam. <i>Condition</i> , badly obstructed by trees 2 to 12 inches in diameter covering side slopes, except intervals aggregating half length of right bank occupied by large weeds and bushy willows; no foliage. <i>Constructed</i> , 1902; cleared, about 1910. (Pl. 27, A and fig. 19, F.)
Mar. 16, 1925	3.3	19.8	45.5	46.1	.99	2.09	.000503	.052	
Feb. 25, 1926	6.1	29.3	100.7	114.5	.88	3.44	.000397	.077

Aug. 8, 1924	4.4	24.0	67.1	71.0	0.95	2.60	0.000591	0.070	Condition, as described above, but with summer foliage, and three-fourths of length of bottom covered with short weeds.
June 6, 1924	4.8	25.1	72.2	79.9	.90	2.82	.000500	.072	
do.	5.4	26.9	85.6	96.5	.89	3.15	.000424	.074	
Aug. 21, 1924	6.4	30.5	120.4	124.8	.96	3.60	.000473	.080	
Aug. 20, 1924	8.8	40.8	206.1	207.4	.99	4.49	.000503	.097

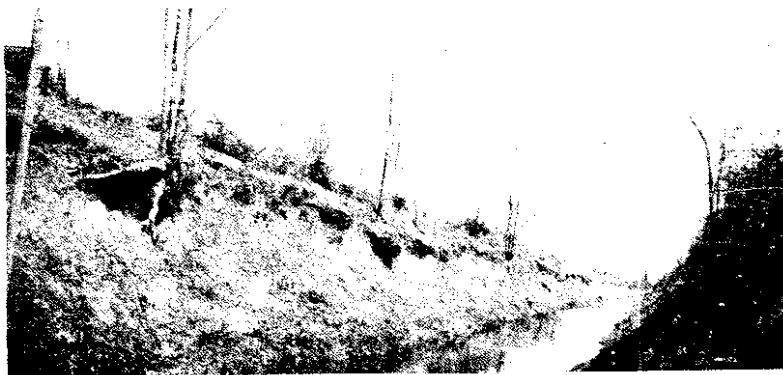
Date of observation	Average maximum depth	Average surface width	Discharge	Average cross section	Mean velocity	Mean hydraulic radius	Slope of water surface	Coefficient of roughness $n$	Description of channel
Mar. 5, 1914	4.0	19.5	45.0	50.0	0.90	2.28	0.000358	0.052	Course, straight; 1,224 feet long. <i>Cross section</i> , slight and gradual variations in shape; for variation in size, see fig. 2, A. <i>Side slopes</i> , right side irregular, left side very irregular. <i>Bottom</i> , irregular and uneven. <i>Soil</i> , varies from black waxy clay at top to yellow clay at bottom. <i>Condition</i> , right side slope and part of bottom practically covered with small saplings, brush, and cane, occasional growths of vegetation on other side slopes. <i>Constructed</i> , Dec. 1907.
Mar. 20, 1914	4.3	20.0	59.7	58.0	1.03	2.43	.000350	.047	
Apr. 17, 1914	4.65	21.0	77.9	60.4	1.29	2.55	.000377	.041	
Apr. 9, 1914	5.3	22.2	105.4	74.2	1.42	2.85	.000292	.035

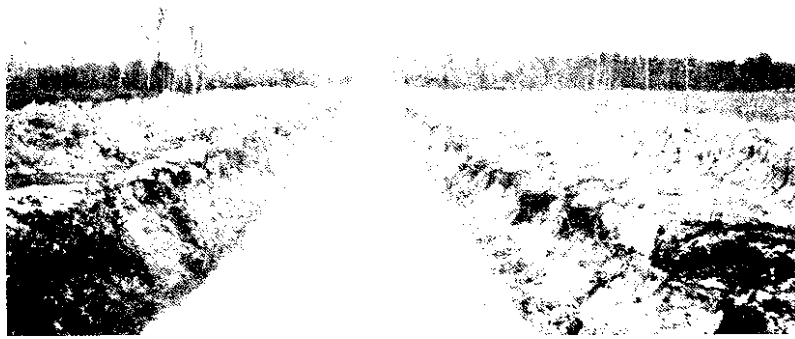
Date of observation	Average maximum depth	Average surface width	Discharge	Average cross section	Mean velocity	Mean hydraulic radius	Slope of water surface	Coefficient of roughness $n$	Description of channel
Apr. 11, 1914	2.6	18.5	54.8	40.0	1.37	1.8	0.000300	0.027	<i>Course, straight; 1,194 feet long. Cross section, very little variation in shape; for variation in size see fig. 2, B. Side slopes, quite regular. Bottom, even and regular. Soil, sandy, waxlike clay. Condition, newly dredged channel; no vegetation or obstructions of any sort in channel. Constructed, January, 1913. (Pl. 1, C and fig. 1, B.)</i>
do	2.8	19.3	61.9	43.0	1.44	1.9	.000305	.027	
Apr. 7, 1914	2.9	19.5	64.8	43.2	1.50	1.9	.000305	.026	
Apr. 9, 1914	3.2	20.5	74.9	47.7	1.57	2.1	.000310	.027	
Apr. 5, 1914	3.8	22.0	115.0	57.5	2.00	2.3	.000301	.022	
Mar. 28, 1914	4.0	22.6	125.0	61.0	2.05	2.5	.000349	.025	
Mar. 26, 1914	4.1	22.8	130.2	62.6	2.08	2.6	.000336	.025

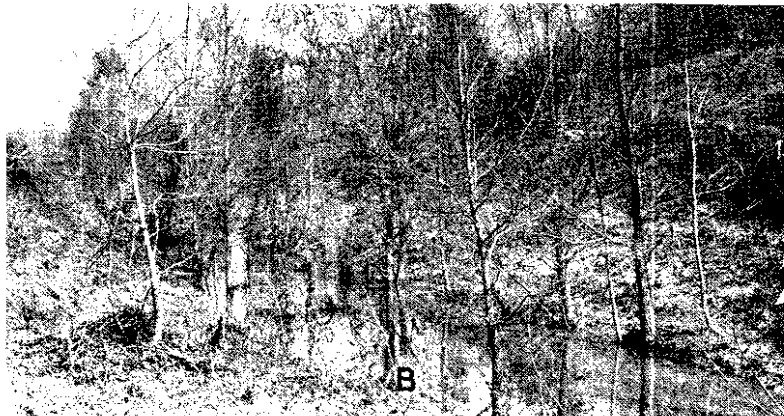
Date of observation	Average maximum depth	Average surface width	Discharge	Average cross section	Mean velocity	Mean hydraulic radius	Slope of water surface	Coefficient of roughness $n$	Description of channel
Feb. 21, 1925	3.0	22.7	22.0	46.5	0.47	1.91	0.000124	0.049	<i>Course, straight; 810 feet long. Cross section, quite uniform in shape; for variation in size, see fig. 15, B. Side slopes, irregular and uneven. Bottom, irregular and uneven. Soil, heavy silty clay. Condition, practically entire section filled with large sized growth of trees consisting principally of willows and cottonwoods. Constructed, June, 1918. (Pl. 17, B and fig. 14, B.)</i>
Mar. 15, 1925	4.5	30.4	55.2	85.0	.65	2.61	.000151	.051	
Feb. 19, 1926	4.7	31.4	61.1	93.0	.66	2.75	.000104	.044	
Mar. 22, 1926	5.5	34.4	86.7	118.0	.73	3.21	.000116	.048	
Jan. 23, 1926	6.5	39.3	125.1	156.7	.80	3.70	.000152	.056	
Jan. 27, 1926	6.7	40.1	108.6	162.5	.67	3.75	.000109	.057

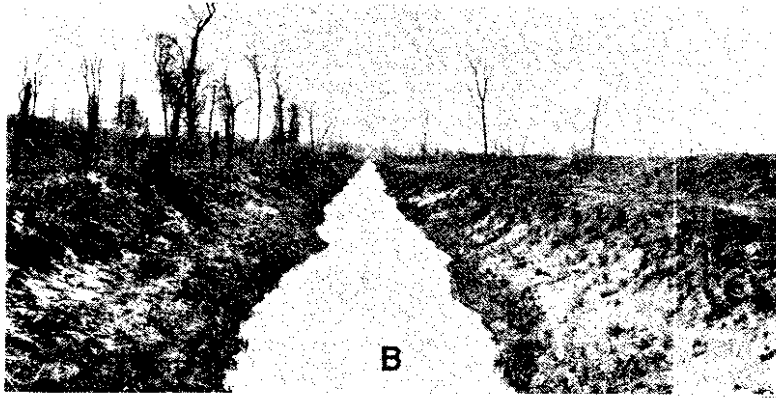
Date of observation	Average maximum depth	Average surface width	Discharge	Average cross section	Mean velocity	Mean hydraulic radius	Slope of water surface	Coefficient of roughness $n$	Description of channel
Jan. 26, 1923	3.2	17.7	26.6	39.0	0.68	2.00	0.000058	0.025	<i>Course</i> , straight; 800 feet long. <i>Cross section</i> , very little variation in shape; for variation in size, see figure 18, D. <i>Side slopes</i> , quite regular. <i>Bottom</i> , fairly regular. <i>Soil</i> , dark, heavy, tenacious clay. <i>Condition</i> , newly cleared channel, practically no vegetation. <i>Constructed</i> , December, 1914. (Pl. 21, B and fig. 17, D.)
Jan. 25, 1923	3.5	18.4	34.9	45.1	.77	2.18	0.00070	.026	
Mar. 6, 1923	3.8	19.2	43.9	50.7	.87	2.34	0.00086	.027	
Jan. 24, 1923	4.5	21.0	57.9	62.6	.92	2.64	0.00080	.027	
Apr. 13, 1923	5.2	23.2	91.6	78.8	1.16	3.01	0.00108	.028	
Jan. 23, 1923	5.8	25.2	91.9	93.8	.98	3.28	0.00069	.028

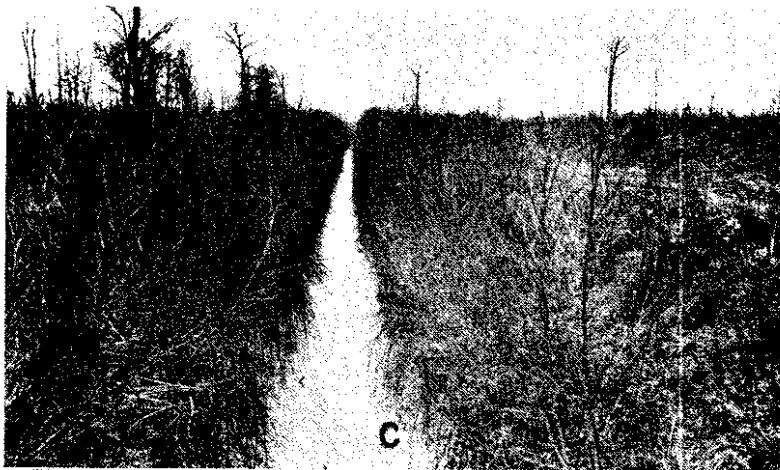
Date of observation	Average maximum depth	Average surface width	Discharge	Average cross section	Mean velocity	Mean hydraulic radius	Slope of water surface	Coefficient of roughness $n$	Description of channel
									<i>Course</i> , straight; 800 feet long. <i>Cross section</i> , very little variation in shape; for variation in size, see figure 18, D. <i>Side slopes</i> , quite regular. <i>Bottom</i> , fairly regular. <i>Soil</i> , dark, heavy, tenacious clay. <i>Condition</i> , newly cleared channel, practically no vegetation. <i>Constructed</i> , December, 1914.
Nov. 29, 1925	6.6	27.4	81.7	115.0	0.71	3.66	27.2	0.069	Same channel as above with about 2 years' growth of willows. (Pl. 21, C.)
Nov. 28, 1925	7.4	29.7	99.6	136.5	.73	3.98	26.4	.073

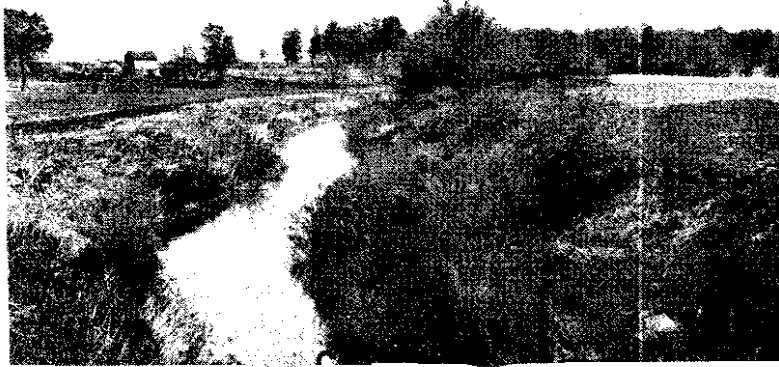
Date of observation	Average maximum depth	Average surface width	Discharge	Average cross section	Mean velocity	Mean hydraulic radius	Slope of water surface	Coefficient of roughness $n$	Description of channel
Jan. 18, 1926	5.2	37.6	249.1	130.6	1.91	3.15	0.00383	0.033	<i>Course, crooked; 600 feet long. Cross section, considerable variation in shape; for variation in size, see fig. 20, H. Side slopes, very irregular and uneven. Bottom, fairly even and regular. Soil, lower part, light bluish gray clay, which is hard, waxy, and slippery at the bottom; upper part, gray silt loam. Condition, very young growth and stubble on upper part of slopes, none on lower part; channel cleared in September, 1925. Constructed, 1907; vegetation cut about every 2 years. (Pl. 26, C and fig 19, H.)</i>
Feb. 26, 1926	6.2	43.0	321.0	169.5	1.89	3.58	.00485	.041	
Feb. 25, 1926	7.1	47.1	413.6	210.0	1.98	4.04	.00515	.044	
Apr. 7, 1926	7.6	49.2	454.4	236.8	1.92	4.35	.00463	.046

June 12, 1926	2.8	25.6	70.7	56.2	1.26	2.02	53.6	0.030	<i>Condition, left slope covered with weeds, right slope with willows, except near bottom.</i>
Sept. 17, 1926	3.2	26.8	69.8	66.8	1.04	2.28	44.4	.037	
Sept. 7, 1926	4.2	31.5	99.3	95.1	1.04	2.74	38.7	.044	
Sept. 13, 1926	4.9	36.2	138.4	120.5	1.15	3.04	39.1	.045	
Sept. 6, 1926	6.4	43.8	197.1	177.5	1.11	3.68	35.2	.053	
Sept. 5, 1926	7.4	48.3	260.2	225.4	1.15	4.22	28.9	.068	
Sept. 11, 1926	8.4	51.6	320.8	273.2	1.17	4.76	28.3	.072

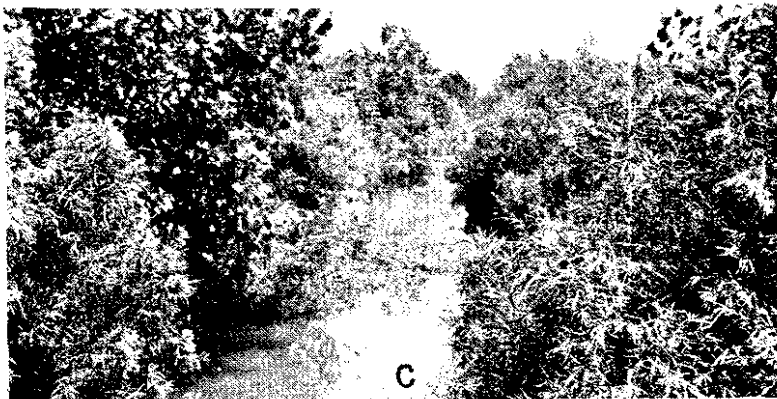
Date of observation	Average maximum depth	Average surface width	Discharge	Average cross section	Mean velocity	Mean hydraulic radius	Slope of water surface	Coefficient of roughness $n$	Description of channel
Sept. 10, 1926	Feet 4.6	Feet 28.6	Second-feet 60.9	Sq. ft. 87.9	Ft. per sec. 0.69	Feet 2.84	0.000516	0.095	<i>Course, straight; 661 feet long. Cross section, very little variation in shape; for variation in size, see fig. 20, J. Side slopes, fairly regular. Bottom, uneven and irregular. Soil, lower part, yellowish gray clay; upper part, light gray silty clay loam. Condition, in 1924, newly cleaned leaving weeds and stubble on side slopes; in 1926, sides covered with trees and vines without foliage. Constructed, 1906; cleaned, winter of 1923-24.</i>
Oct. 2, 1926	7.3	36.0	164.9	175.7	.94	4.37	.000546	.104	
	18.5

*Condition, side slopes covered with heavy growth of poplar trees 2 to 3 inches in diameter, large willows, and climbing vines; thick growth of water weed on bottom. (Pl. 29, C.)*

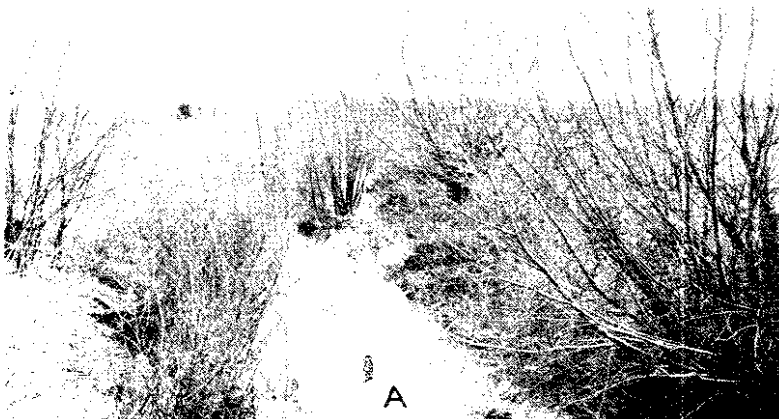
Date of observation	Average maximum depth	Average surface width	Discharge	Average cross section	Mean velocity	Mean hydraulic radius	Slope of water surface	Coefficient of roughness <i>n</i>	Description of channel
Mar. 13, 1925	2.7	18.3	25.6	32.6	0.79	1.64	0.000558	0.056	<i>Course</i> , straight; 360 feet long. <i>Cross section</i> , considerable variation in shape; for variation in size, see fig. 20, I. <i>Side slopes</i> , irregular. <i>Bottom</i> , very irregular. <i>Soil</i> , lower part, black slippery clay; upper part, gray silty clay loam. <i>Condition</i> , about 100 feet of course covered with dense growth of bushy willows, some in bottom; remainder of both slopes covered with weeds and a scattering growth of willows and poplars 1 to 6 inches in diameter; no foliage; some silting in bottom. <i>Constructed</i> , dredged 1905; cleared, 1921. (Pl. 28, A and fig. 19, I.)
Jan. 19, 1926	4.0	22.3	44.2	59.7	.74	2.43	.000550	.081

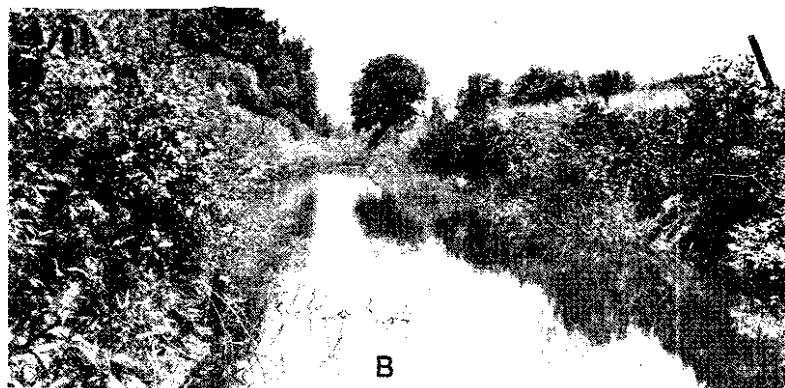
Date of observation	Average maximum depth	Average surface width	Discharge	Average cross section	Mean velocity	Mean hydraulic radius	Slope of water surface	Coefficient of roughness <i>n</i>	Description of channel
Sept. 7, 1926	5.2	28.4	64.0	101.6	0.63	3.24	0.000326	0.093	<i>Course</i> , straight; 800 feet long. <i>Cross section</i> , very little variation in shape; for variation in size, see Figure 20, E. <i>Side slopes</i> , rather irregular. <i>Bottom</i> , uneven and rather irregular. <i>Soil</i> , lower part, yellowish gray clay; upper part dark-gray silt loam. <i>Condition</i> , dead weeds and stubble on side slopes; channel had been cleared shortly before March, 1925. <i>Constructed</i> , 1885; dredged about 1904.
Sept. 5, 1926	6.1	30.5	77.2	126.8	.61	3.70	.000279	.100	
Sept. 13, 1926	7.2	33.5	124.6	162.1	.77	4.25	.000330	.097	
Sept. 11, 1926	8.8	41.3	170.8	222.2	.77	4.75	.000308	.103

*Condition*, left side rather steep, showing some tendency to cave; brush larger on side slopes; foliage on all vegetation. (Pl. 26, B.)

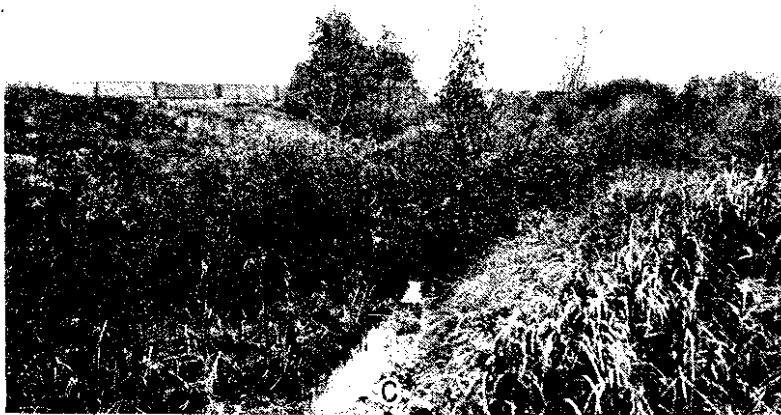
Date of observation	Average maximum depth	Average surface width	Discharge	Average cross section	Mean velocity	Mean hydraulic radius	Slope of water surface	Coefficient of roughness $n$	Description of channel
Sept. 30, 1926	2.3	17.0	12.4	19.2	0.65	1.06	0.003169	0.106	<i>Course, crooked; 360 feet long. Cross section, considerable variation in shape; for variation in size, see fig. 20, M. Side slopes, irregular. Bottom, very irregular. Soil, lower part, dark gray clay with some sand and pebbles; upper part, dark gray silty clay loam. Condition, slopes covered with dense growth of tall weeds, bushes, and wiry grass; occasional bushy willows, and trees 6 to 9 inches in diameter; bottom very grassy, except narrow winding strip. Constructed, about 1890. (Pl. 28, C and fig. 19, M.)</i>
Oct. 3, 1925	2.5	17.8	16.7	23.6	.71	1.23	.003406	.114	
Sept. 13, 1925	2.8	18.6	21.1	28.4	.74	1.41	.003422	.122	
Sept. 4, 1926	3.6	20.5	34.4	44.2	.78	1.96	.003131	.149

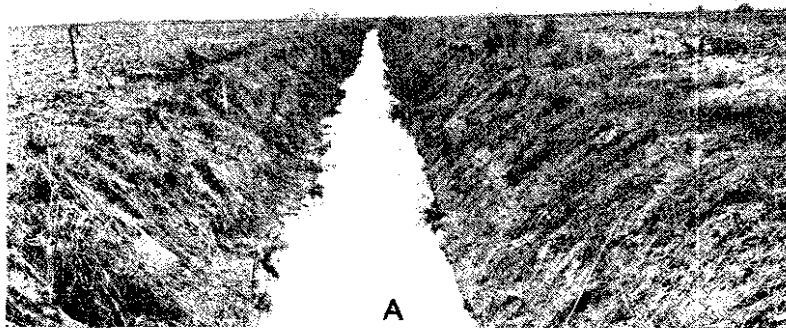
Date of observation	Average maximum depth	Average surface width	Discharge	Average cross section	Mean velocity	Mean hydraulic radius	Slope of water surface	Coefficient of roughness $n$	Description of channel
Mar. 26, 1925	1.8	15.0	17.8	18.0	0.99	1.16	0.000512	0.034	<i>Course, straight; 1,000 feet long. Cross section, practically no variation in shape; for variation in size, see fig. 20, K. Side slopes, quite regular. Bottom, somewhat irregular. Soil, lower part, slippery gray clay; upper part, grayish tan silty clay loam. Condition, good; dead weeds practically flat on side slopes. Constructed, 1886; redredged, 1922. (Pl. 30, A and fig. 19, K.)</i>
Mar. 16, 1925	2.6	17.3	28.7	30.5	.94	1.65	.000384	.040	
Mar. 14, 1925	3.8	20.0	77.7	53.4	1.46	2.39	.000237	.028	
Mar. 19, 1925	4.4	21.3	82.0	67.0	1.22	2.78	.000175	.031

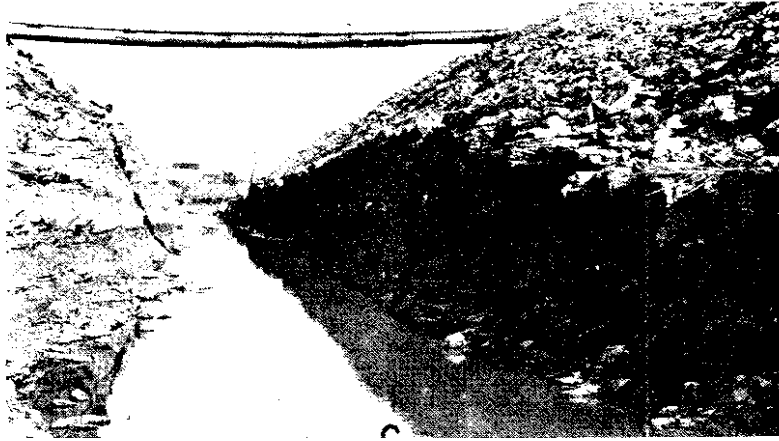
Date of observation	Average maximum depth	Average surface width	Discharge	Average cross section	Mean velocity	Mean hydraulic radius	Slope of water surface	Coefficient of roughness $n$	Description of channel
July 12, 1924	2.5	15.4	115.0	35.6	3.23	1.93	0.001898	0.030	<i>Course, straight; 250 feet long. Cross section, very little variation in shape; for variation in size, see fig. 18, F. Side slopes, fairly regular. Bottom, quite even and regular. Soil, limestone rock. Condition, same channel as above, enlarged and smoothed by hand. Constructed, December, 1922. (Pl. 23, C and fig. 17, F.)</i>
July 10, 1924	2.9	15.6	146.2	42.0	3.48	2.19	.001898	.031	
Jan. 30, 1923	3.1	15.8	156.9	45.0	3.49	2.30	.001750	.030	
Mar. 18, 1927	3.8	16.1	230.3	56.6	4.07	2.68	.002872	.037	
Feb. 1, 1923	4.3	16.3	265.2	63.3	4.19	2.88	.002690	.037	
Mar. 18, 1927	4.3	16.3	280.8	64.1	4.38	2.91	.002913	.037	
do	4.7	16.6	353.5	71.5	4.94	3.10	.003142	.036

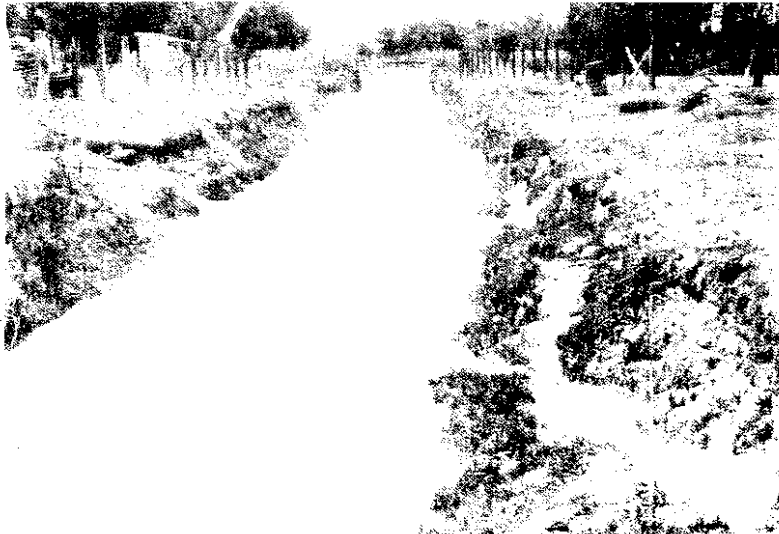
Date of observation	Average maximum depth	Average surface width	Discharge	Average cross section	Mean velocity	Mean hydraulic radius	Slope of water surface	Coefficient of roughness $n$	Description of channel
Feb. 15, 1917	0.7	12.5	7.9	8.9	0.89	0.67	0.002080	0.047	<i>Course, straight; 308 feet long. Cross section, abrupt variations in shape; for variation in size, see fig. 6, J. Side slopes, very irregular and rough. Bottom, uneven; subject to variation due to sand deposits. Soil, clay loam. Condition, exposed perimeter above low water practically covered with grass and weeds. Constructed, December, 1915. (Pl. 9, A and fig. 5, J.)</i>
July 23, 1917	2.3	17.3	72.4	33.8	2.14	1.76	.002435	.047	
do	2.9	18.8	103.7	42.1	2.46	1.99	.001915	.040	
do	5.5

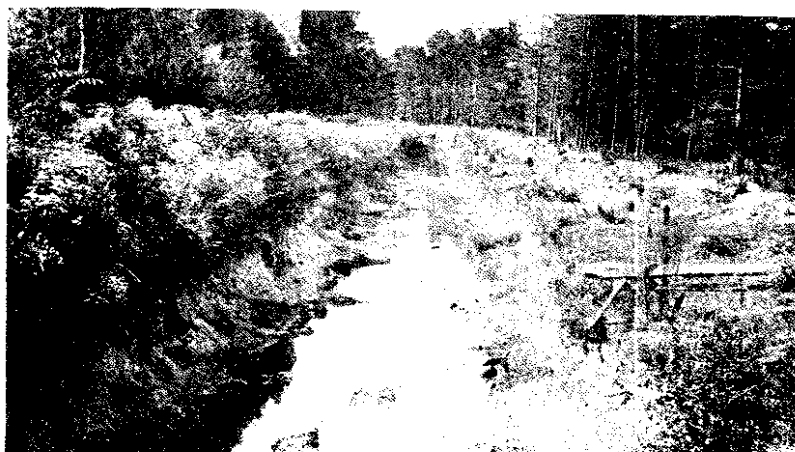
Date of observation	Average maximum depth	Average surface width	Discharge	Average cross section	Mean velocity	Mean hydraulic radius	Slope of water surface	Coefficient of roughness $n$	Description of channel
Mar. 29, 1917	1.9	17.3	23.1	25.4	0.91	1.37	0.000729	0.050	<i>Course</i> , 669 feet long; first half straight, last half curved. <i>Cross section</i> , very little variation in shape; for variations in size, see fig. 6, I. <i>Slide slopes</i> , upper part, smooth and regular; lower part, rather rough. <i>Bottom</i> , very rough and irregular with numerous holes. <i>Soil</i> , stiff clay loam; does not wash easily. <i>Condition</i> , some roots extending from sides of channel; very little vegetation in channel. <i>Constructed</i> , Dec., 1915. <i>Remarks</i> , very rough condition of bottom is mainly responsible for high values of $n$ obtained. (Pl. 8, B and fig. 5, I.)
Mar. 27, 1917	2.1	17.5	29.8	29.2	1.02	1.53	.000825	.059

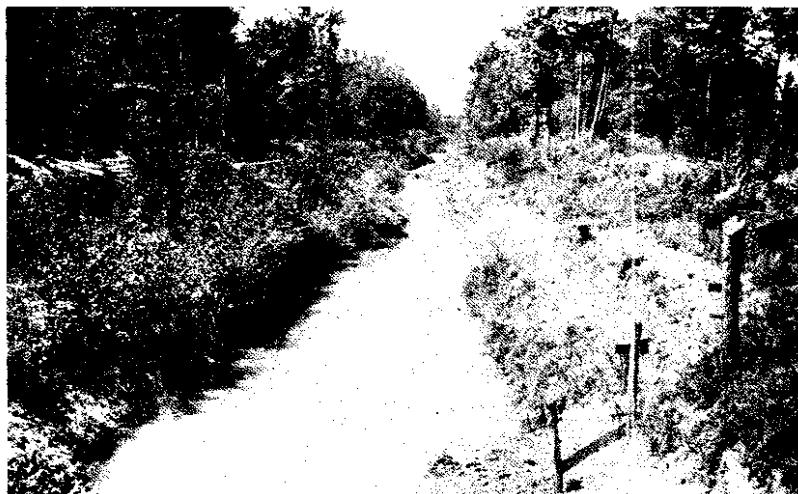
Date of observation	Average maximum depth	Average surface width	Discharge	Average cross section	Mean velocity	Mean hydraulic radius	Slope of water surface	Coefficient of roughness $n$	Description of channel
Dec. 8, 1916	2.0	18.9	49.1	35.4	1.39	1.72	0.000738	0.040	<i>Course</i> , straight; 618 feet long; part of 1916 course. <i>Condition</i> , channel in considerably worse condition than when first series of measurements were made; more irregular and rough due to caving banks and a great deal more vegetation in channel. (Pl. 8, A and fig. 6, H.)
do	2.3	19.6	63.2	40.5	1.56	1.87	.000713	.037	
Dec. 28, 1916	2.55	20.1	88.2	46.0	1.92	2.06	.000888	.037	
Feb. 15, 1917	2.60	20.2	88.4	47.0	1.88	2.09	.000834	.036	
Dec. 28, 1916	3.0	20.8	115.2	55.9	2.06	2.34	.000835	.036	
Jan. 18, 1917	3.2	21.1	123.6	58.8	2.10	2.42	.000832	.036	
Mar. 3, 1917	3.5	22.2	143.6	64.3	2.23	2.55	.000877	.036	
	6.3

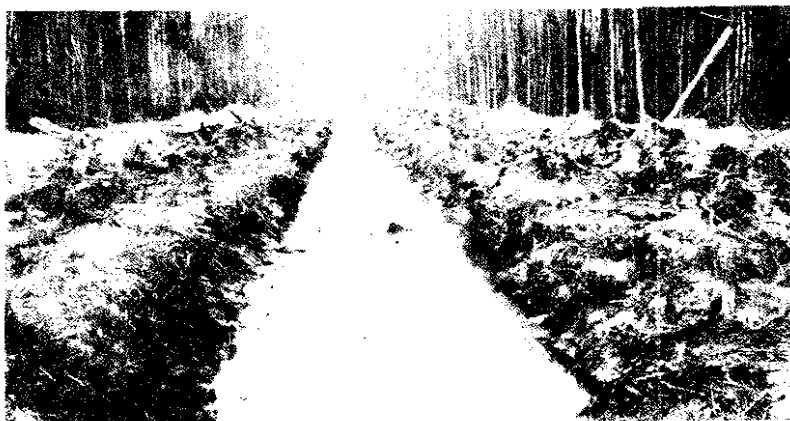
Date of observation	Average maximum depth	Average surface width	Discharge	Average cross section	Mean velocity	Mean hydraulic radius	Slope of water surface	Coefficient of roughness $n$	Description of channel
Apr. 22, 1915	2.5	22.5	28.5	25.3	1.13	1.22	0.000792	0.038	<i>Course, straight; 250 feet long. Cross section, abrupt variations in shape; for variation in size, see fig. 11, B. Side slopes, fairly regular. Bottom, fairly regular, some holes. Soil, sandy clay. Condition, mat of overhanging ragged roots on both side slopes; no weeds or grass in channel; some roots in bottom. Constructed, winter 1913. (Pl. 13, C and fig. 10, B.)</i>
Feb. 10, 1915	2.9	23.1	40.0	32.0	1.25	1.45	.000880	.042	
May 17, 1915	3.1	23.3	58.6	35.5	1.65	1.57	.000850	.034	
Feb. 3, 1915	4.4	24.6	129.6	66.0	1.96	2.51	.000624	.034	
Jan. 20, 1915	5.1	25.2	171.9	83.1	2.07	2.98	.000600	.036	
May 13, 1915	5.7	25.8	232.5	98.8	2.35	3.34	.000730	.038

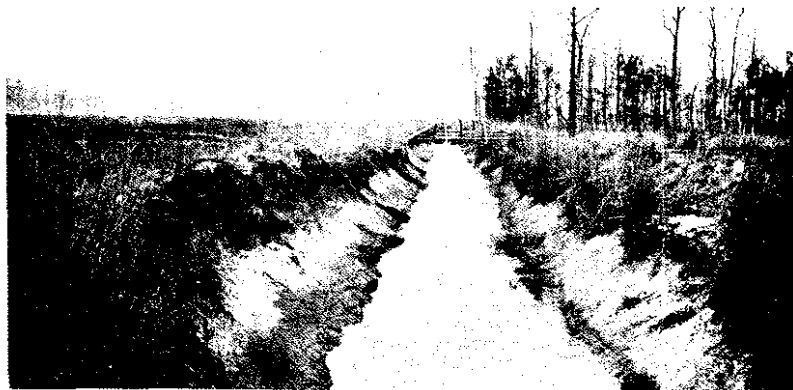
Date of observation	Average maximum depth	Average surface width	Discharge	Average cross section	Mean velocity	Mean hydraulic radius	Slope of water surface	Coefficient of roughness $n$	Description of channel
Feb. 5, 1913	2.8	18.7	75.0	41.0	1.83	1.95	0.000850	0.036	<i>Course, straight; 320 feet long. Cross section, very little variation in shape; for variation in size, see fig. 2, D. Side slopes, quite regular except near top and along edge of bottom. Bottom, quite regular. Soil varies from a sandy loam at top to a waxy clay at bottom. Condition, very little vegetation in channel; irregularity of upper part of channel due to erosion. Constructed, May, 1911. (Pl. 2, B and fig. 1, D.)</i>
Apr. 5, 1913	7.3	31.2	368.1	156.0	2.36	4.20	.000406	.034	
Feb. 28, 1913	11.1	36.4	1,152.6	282.5	4.08	6.05	.000935	.038	
	12.0

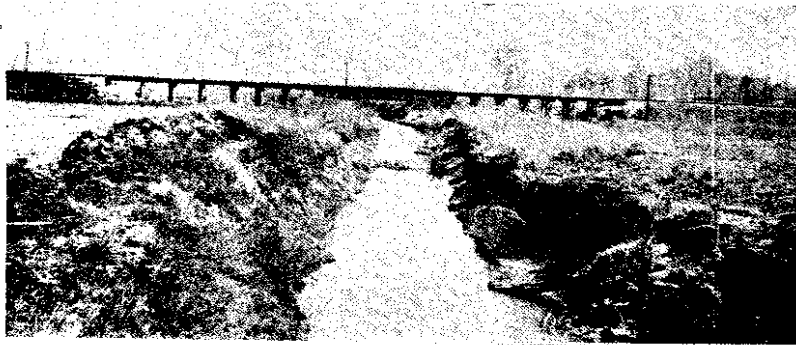
Date of observation	Average maximum depth	Average surface width	Discharge	Average cross section	Mean velocity	Mean hydraulic radius	Slope of water surface	Coefficient of roughness <i>n</i>	Description of channel
Apr. 4, 1913	10.6 12.0	36.7	850.0	286.2	2.97	5.95	0.006620	0.043	<i>Course</i> , straight; 450 feet long. <i>Cross section</i> , rather gradual variations in shape; for variations in size, see fig. 2, E. <i>Side slopes</i> , very irregular. <i>Bottom</i> , irregular and uneven. <i>Soil</i> , clay loam. <i>Condition</i> , some grass and other vegetation on side slopes; bottom free from growth. <i>Constructed</i> , May, 1909. (Pl. 2, C and fig. 1, E.)

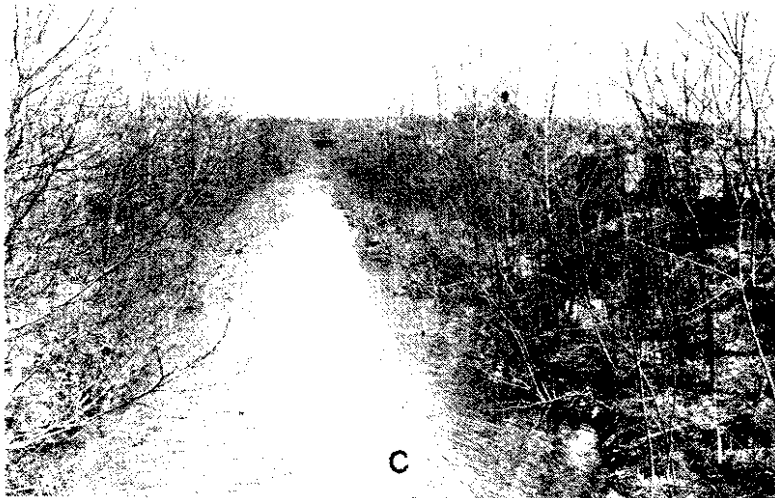
Date of observation	Average maximum depth	Average surface width	Discharge	Average cross section	Mean velocity	Mean hydraulic radius	Slope of water surface	Coefficient of roughness <i>n</i>	Description of channel
May. 1, 1924	3.4	29.4	148.4	80.4	1.85	2.50	0.001118	0.048	<i>Course</i> , straight; 550 feet long. <i>Cross section</i> , some variation in shape; for variation in size, see fig. 20, D. <i>Side slopes</i> , irregular. <i>Bottom</i> , rather irregular. <i>Soil</i> , lower part, probably clay originally but now mixed with a large percentage of sand; upper part, boulder clay, quite stony. <i>Condition</i> , side slopes covered with rather thick growth of small trees and sprouts of maple, elm, poplar, box elder, and some willow, from 1/2 inch to 8 inches in diameter; no grass; stones on bottom up to 1 foot in diameter; no appreciable silting. <i>Constructed</i> , about 1908. (Pl. 24, C and fig. 19, D.)

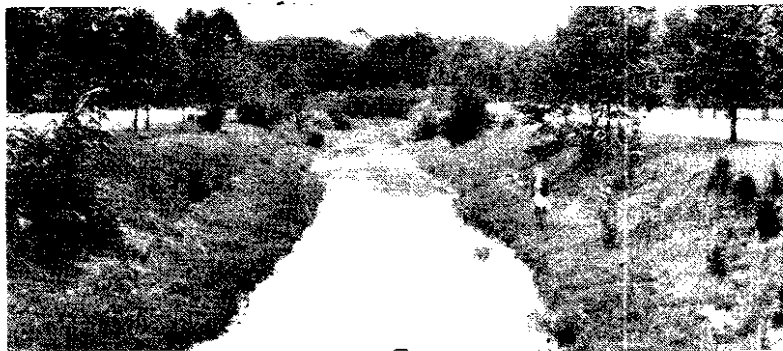
Date of observation	Average maximum depth	Average surface width	Discharge	Average cross section	Mean velocity	Mean hydraulic radius	Slope of water surface	Coefficient of roughness $n$	Description of channel
May 1, 1924	2.7	29.2	148.4	57.5	2.58	1.84	0.000844	0.025	<i>Course, straight; 450 feet long. Cross section, very little variation in shape; for variation in size, see fig. 20, C. Side slopes, fairly regular. Bottom, quite flat but somewhat irregular in places. Soil, bottom covered with stones and gravel; upper part, bowlder clay with oxidized iron. Condition, some small sprouts, bushes and dead grass on side slopes, without foliage; bottom covered with mossy stones at lower end of course, but mostly with gravel at upper end. Constructed, about 1908 (Pl. 24, B and fig. 19, C.)</i>
Apr. 26, 1924	2.9	30.6	151.2	65.4	2.31	2.01	.000898	.030	
Mar. 20, 1925	3.9	35.5	286.1	91.5	3.13	2.42	.000833	.026

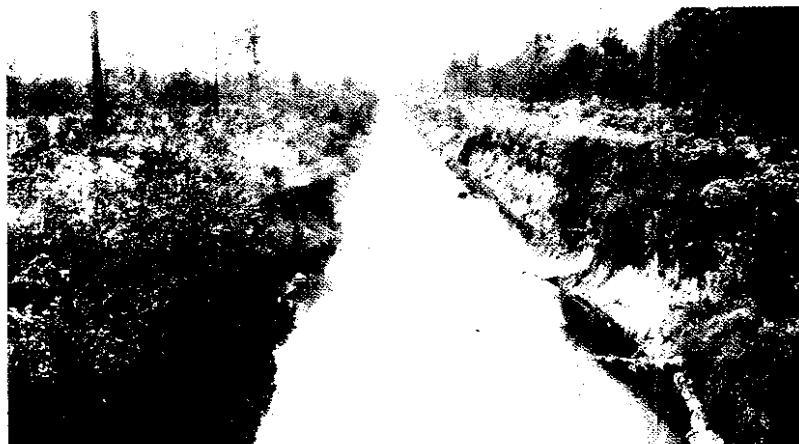
Date of observation	Average maximum depth	Average surface width	Discharge	Average cross section	Mean velocity	Mean hydraulic radius	Slope of water surface	Coefficient of roughness $n$	Description of channel
Mar. 30, 1916	3.2	26.1	115.2	73.3	1.57	2.46	0.000257	0.028	<i>Course, straight; 624 feet long. Cross section, very little variation in shape; for variation in size, see Fig. 6, C. Side slopes, slightly irregular. Bottom, fairly regular; uneven in places with small depressions. Soil, heavy clay near bottom; clay loam near top. Condition, practically no vegetation in channel. Constructed, November, 1914. (Pl. 7, B and fig. 5, C.)</i>
Mar. 1, 1916	3.8	27.1	169.4	89.0	1.90	2.81	.000393	.031	
May 16, 1916	3.9	27.4	193.2	91.5	2.11	2.87	.000305	.025	
May 22, 1916	5.8	30.4	358.0	147.0	2.43	3.96	.000361	.029	
May 3, 1916	6.4	31.5	434.6	168.3	2.58	4.34	.000345	.029	
	19.3

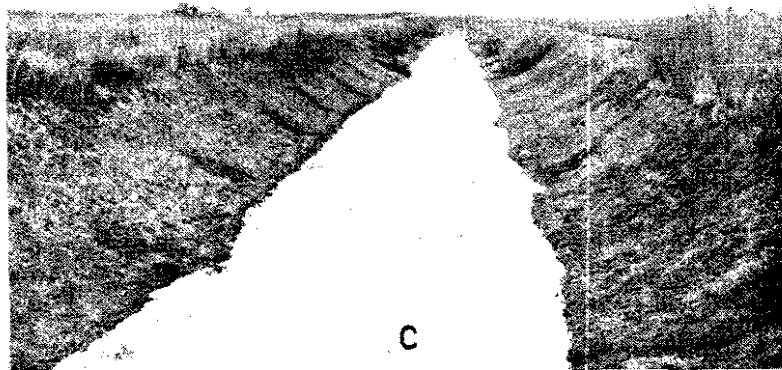
Date of observation	Average maximum depth	Average surface width	Discharge	Average cross section	Mean velocity	Mean hydraulic radius	Slope of water surface	Coefficient of roughness $n$	Description of channel
Jan. 19, 1926	4.5	40.8	158.0	120.4	1.31	2.78	0.000186	0.030	<i>Course</i> , straight; 816 feet long. <i>Cross section</i> , very little variation in shape; for variation in size, see fig. 20, B. <i>Side slopes</i> , fairly regular. <i>Bottom</i> , uneven and irregular. <i>Soil</i> , lower part, light gray clay; upper part, yellowish gray clay. <i>Condition</i> , side slopes covered with dense growth of bushy willows, except near bottom; some small poplar saplings at intervals along course; one silt bar about middle of course, otherwise bottom in quite good condition. <i>Constructed</i> , 1885; redredged, 1909.
Feb. 26, 1926	6.1	46.8	296.1	189.7	1.56	3.79	.000169	.030	
Apr. 9, 1926	6.8	48.8	332.0	220.7	1.50	4.19	.000146	.032

Apr. 8, 1926	7.9	52.2	461.1	279.6	1.65	4.91	.000142	.032	
	113.0								
<p><sup>1</sup> Average maximum depth at bankful stage.</p>									
<p><i>Condition</i>, practically no growth in channel; cleared during fall of 1925. (Pl. 25, C.)</p>

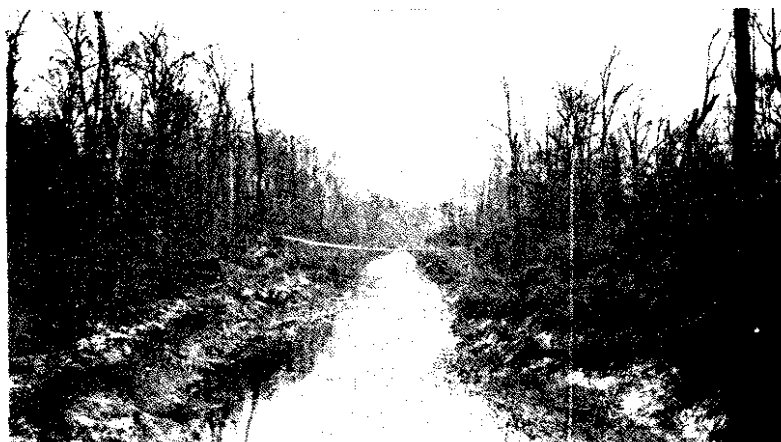
Date of observation	Average maximum depth	Average surface width	Discharge	Average cross section	Mean velocity	Mean hydraulic radius	Slope of water surface	Coefficient of roughness $n$	Description of channel
Jan. 5, 1915	2.55	38.1	50.1	74.8	0.67	1.85	0.000152	0.038	<i>Course</i> , straight; 1,039 feet long. <i>Cross section</i> , slight and gradual variations in shape; for variations in size, see fig. 4, C. <i>Side slopes</i> , right side very irregular and caving badly; left side quite regular. <i>Bottom</i> , rather irregular. <i>Soil</i> , upper part, dark silty loam; lower part, light yellow clay. <i>Condition</i> , upper part right side slope covered with weeds and small tree sprouts; left side slope practically free from vegetation. <i>Constructed</i> September, 1911. (Pl. 4, A and fig. 3, C.)
Jan. 20, 1915	4.05	42.3	183.6	137.0	1.34	3.01	.000183	.031	
Feb. 25, 1915	5.60	47.2	275.9	209.0	1.32	4.08	.000119	.032

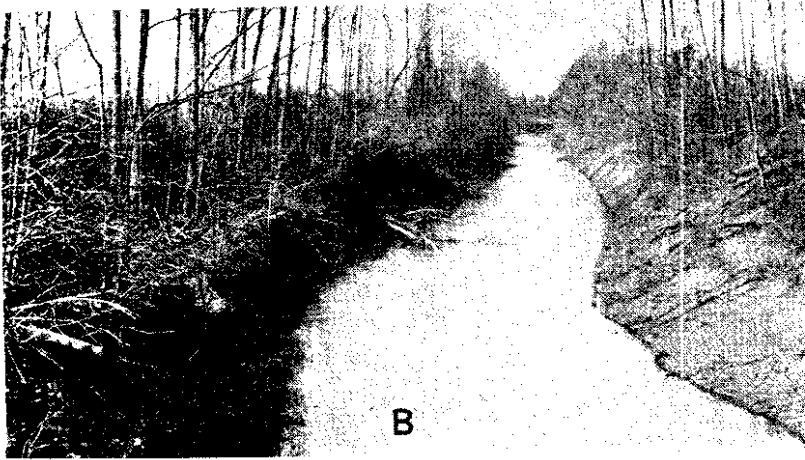
Date of observation	Average maximum depth	Average surface width	Discharge	Average cross section	Mean velocity	Mean hydraulic radius	Slope of water surface	Coefficient of roughness $n$	Description of channel
	<i>Feet</i>	<i>Feet</i>	<i>Second-feet</i>	<i>Sq. ft.</i>	<i>Ft. per sec.</i>	<i>Feet</i>			
Mar. 13, 1926	4.2	40.4	134	117	1.15	2.77	0.000130	0.029	<i>Course</i> , straight, 1,000 feet long, nearly same as above. <i>Cross section</i> , slight variation in shape; for variation in size, see fig. 4, D. <i>Side slopes</i> , fairly even and regular. <i>Bottom</i> , rather irregular. <i>Soil</i> , same as above. <i>Condition</i> , banks fairly clean and free from vegetation. <i>Constructed</i> , September, 1911. (Pl. 4, B and fig. 3, D.)
Mar. 9, 1926	5.4	44.5	204	169	1.21	3.59	.000114	.031	
Apr. 17, 1924	5.9	45.7	319	184	1.73	3.79	.000147	.026	
Dec. 17, 1925	7.7	52.0	391	286	1.37	5.14	.000099	.034

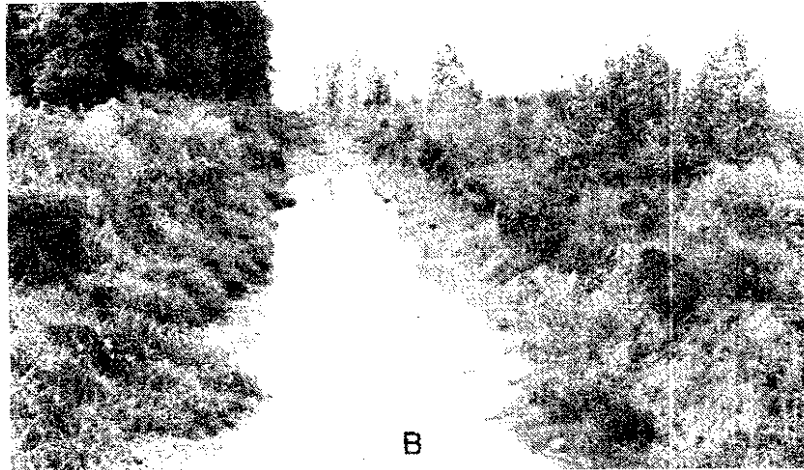
Date of observation	Average maximum depth	Average surface width	Discharge	Average cross section	Mean velocity	Mean hydraulic radius	Slope of water surface	Coefficient of roughness $n$	Description of channel
May 13, 1926	4.1	36.8	55.2	106	0.52	2.75	0.0001315	0.062	<i>Course</i> , straight; 897 feet long. <i>Cross section</i> , slight variation in shape; for variation in size, see fig. 4, G. <i>Side slopes</i> , very irregular and uneven. <i>Bottom</i> , very irregular. <i>Soil</i> , dark colored, waxy clay with thin layers of fine sand which causes slides. <i>Condition</i> , very poor, due to caving banks and weeds and grass. <i>Constructed</i> , May, 1911; redredged, April, 1923. (Pl. 5, B and fig. 3, G.)
May 12, 1926	5.7	42.4	121.0	172	.70	3.79	.0001003	.053	
do.	6.2	44.0	141.0	190	.74	4.03	.0000914	.050	
May 11, 1926	8.2	47.9	258.0	284	.91	5.31	.0000870	.044	
May 28, 1924	8.8	49.0	313.0	316	.99	5.72	.0000726	.038

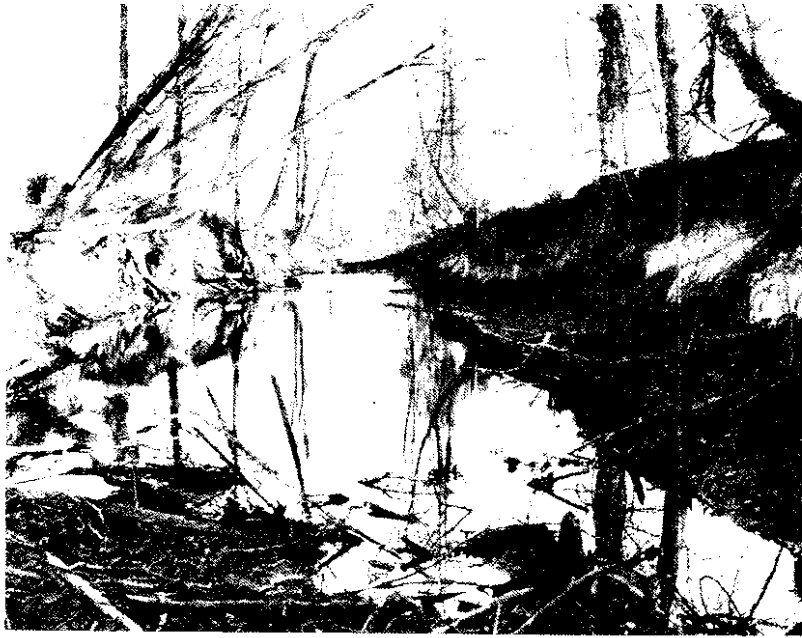
Date of observation	Average maximum depth	Average surface width	Discharge	Average cross section	Mean velocity	Mean hydraulic radius	Slope of water surface	Coefficient of roughness $n$	Description of channel
Mar. 20, 1916	7.0	40.0	395.2	196.2	2.01	4.44	0.000584	0.050	<i>Course</i> , fairly straight; 497 feet long. <i>Cross section</i> , considerable variation in shape; for variation in size, see fig. 6, L. <i>Side slopes</i> , irregular. <i>Bottom</i> , irregular with deep holes. <i>Soil</i> , sandy clay loam. <i>Condition</i> , sides of channel covered with trees, roots, and vines and subject to caving; logs, branches, and other drift on bottom of channel. (Pl. 10, A and fig. 5, L.)
Feb. 25, 1916	8.0	41.7	545.9	240.2	2.27	5.09	.000734	.055	
Mar. 29, 1916	8.8	43.2	735.7	275.0	2.68	5.56	.001088	.062	
Mar. 4, 1916	8.9	43.7	715.1	281.9	2.54	5.66	.000952	.062	
Feb. 3, 1916	11.5	48.8	1,066.6	403.2	2.64	7.19	.000501	.050

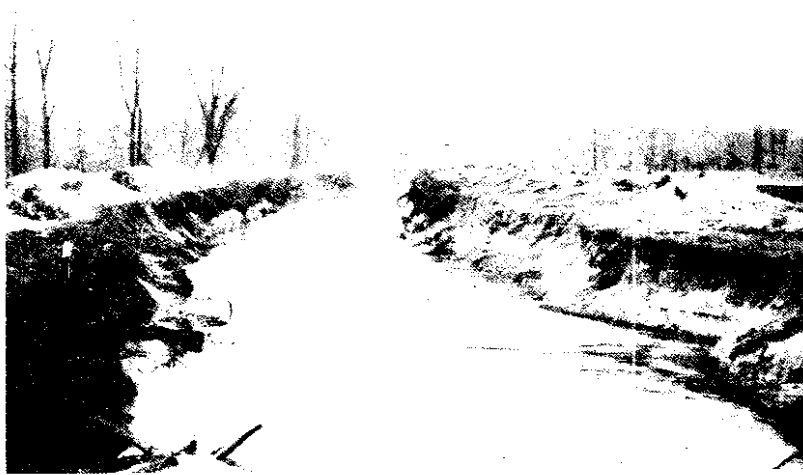
Date of observation	Average maximum depth	Average surface width	Discharge	Average cross section	Mean velocity	Mean hydraulic radius	Slope of water surface	Coefficient of roughness $n$	Description of channel
	<i>Feet</i>	<i>Feet</i>	<i>Second-feet</i>	<i>Sq. ft.</i>	<i>Ft. per sec.</i>	<i>Feet</i>			
Mar. 20, 1916	4.5	43.6	395.2	176.1	2.24	3.61	0.000871	0.038	<i>Course, fairly straight; 534 feet long. Cross section, rather gradual variations in shape; for variation in size, see fig. 6, K. Side-slopes, very irregular. Bottom, very rough and uneven. Soil, sandy clay loam. Condition, very little vegetation; few obstructions in channel. Constructed, August, 1914. (Pl. 9, B and fig. 5, K.)</i>
Feb. 25, 1916	6.1	46.9	545.9	249.0	2.19	4.65	.000552	.046	
Mar. 29, 1916	7.3	49.8	735.7	305.0	2.41	5.33	.000452	.041	
Mar. 4, 1916	7.5	50.3	715.1	315.6	2.27	5.45	.000300	.037	
	13.0

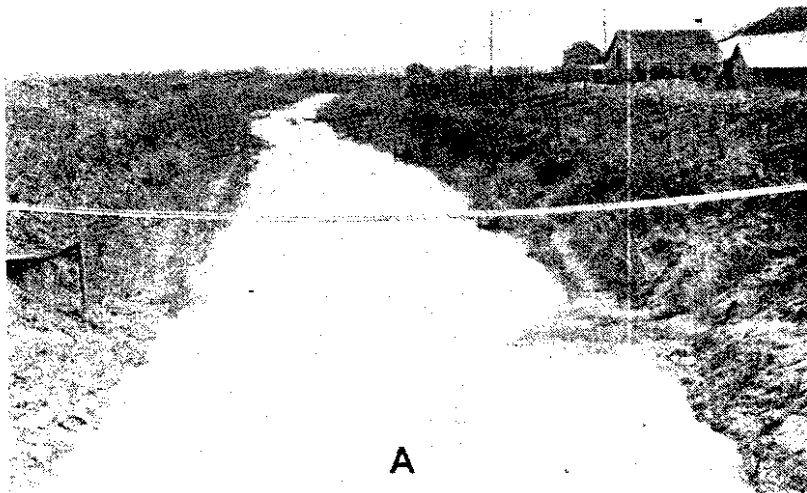
Date of observation	Average maximum depth	Average surface width	Discharge	Average cross section	Mean velocity	Mean hydraulic radius	Slope of water surface	Coefficient of roughness $n$	Description of channel
Mar. 8, 1926	4.8	44.4	163.0	150.8	1.08	3.26	0.000184	0.041	<i>Course, nearly straight; 995 feet long. Cross section, some variation in shape; for variation in size, see fig. 4, J. Side slopes, irregular, varying from steep to almost flat. Bottom, somewhat irregular. Soil, dark clay loam. Condition, growth of short grass and dead weeds in channel, perimeter rather rough. Constructed, February, 1922. (Pl. 6, A and fig. 3, J.)</i>
Mar. 11, 1926	5.4	46.4	206.0	177.0	1.16	3.64	.000176	.041	
	18.0

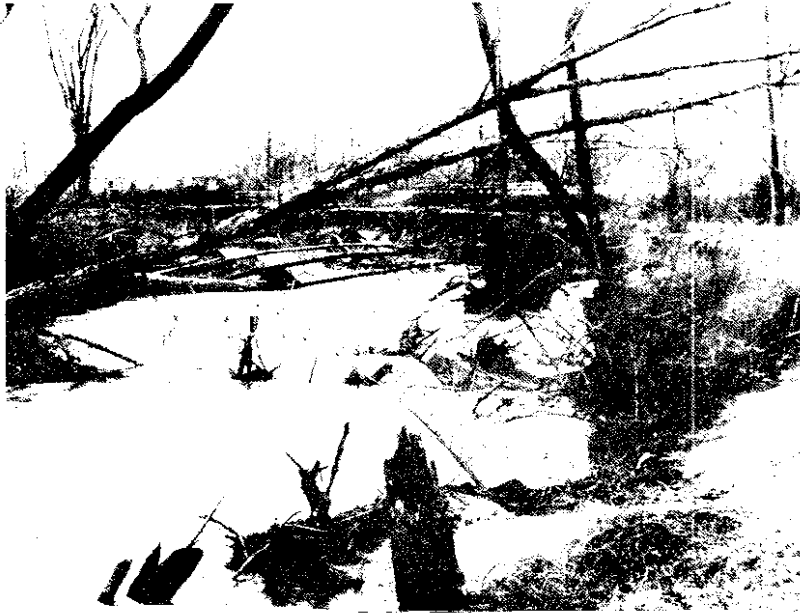
Date of observation	Average maximum depth	Average surface width	Discharge	Average cross section	Mean velocity	Mean hydraulic radius	Slope of water surface	Coefficient of roughness $n$	Description of channel
Mar. 20, 1916	5.1	46.5	395.2	241.2	1.64	4.15	0.003773	0.152	<i>Course</i> , very crooked, containing four distinct curves; 705 feet long at low water. <i>Cross section</i> , large variations in shape; for variation in size, see fig. 6, M. <i>Side slopes</i> , very irregular. <i>Bottom</i> , very irregular and full of holes. <i>Soil</i> , sandy clay loam. <i>Condition</i> , many roots, trees, and bushes on sides, and many logs, large trees, and other drift on bottom; trees are continually falling into channel, due to caving banks. (Pl. 10, B and fig. 5, M.)
Feb. 25, 1916	6.5	50.0	545.9	311.5	1.75	4.99	.003812	.162	
Mar. 29, 1916	7.6	54.0	735.7	366.0	2.01	5.56	.003450	.150	
Mar. 4, 1916	7.8	55.0	715.1	376.7	1.90	5.63	.002709	.146

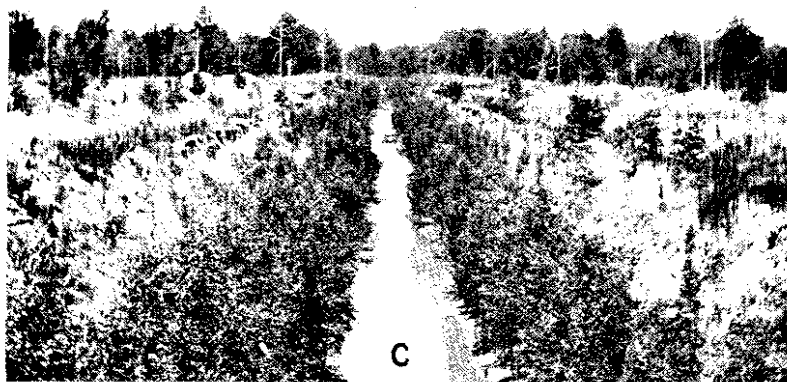
Date of observation	Average maximum depth	Average surface width	Discharge	Average cross section	Mean velocity	Mean hydraulic radius	Slope of water surface	Coefficient of roughness $n$	Description of channel
May 12, 1926	4.0	41.8	55.9	104.5	0.53	2.41	0.000273	0.078	<i>Course</i> , straight; 710 feet long. <i>Cross section</i> , very little variation in shape; for variation in size, see fig. 15, E. <i>Side slopes</i> , fairly regular. <i>Bottom</i> , fairly regular. <i>Soil</i> , upper, sandy loam; lower, silty clay. <i>Condition</i> , growth of willows in channel 6 to 10 feet high except on upper part of side slopes and narrow strip of channel. willows about one year old. <i>Constructed</i> summer 1924
Nov. 11, 1926	7.1	57.8	314.1	262.6	1.20	4.34	.000390	.068	
Nov. 7, 1926	8.4	61.1	410.7	338.8	1.21	5.22	.000315	.070

13.5								<i>Course</i> , same as above. <i>Condition</i> , practically the same, except that willows and other vegetation are in full foliage. (Pl. 18, C.)

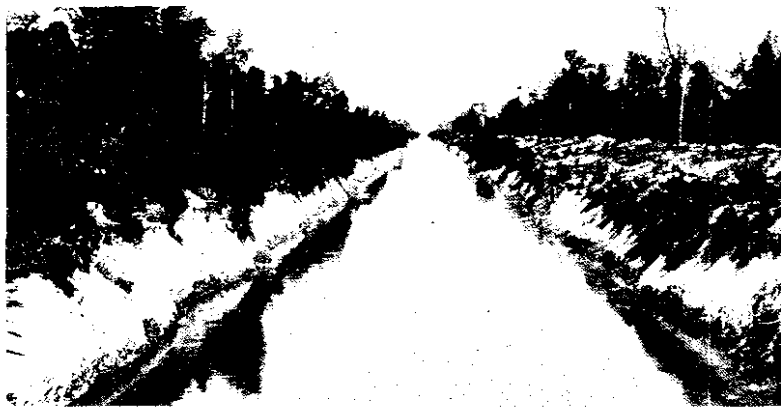
Date of observation	Average maximum depth	Average surface width	Discharge	Average cross section	Mean velocity	Mean hydraulic radius	Slope of water surface	Coefficient of roughness $n$	Description of channel
	<i>Feet</i>	<i>Feet</i>	<i>Second-feet</i>	<i>Sq. ft.</i>	<i>Ft. per sec.</i>	<i>Feet</i>			<i>Course</i> , straight; 1,412 feet long. <i>Cross section</i> , very little variation in shape; for variation in size, see Fig. 6, A. <i>Side slopes</i> , regular and smooth. <i>Bottom</i> , even and fairly smooth. <i>Soil</i> , lower part, hard clay; upper part, clay loam. <i>Condition</i> , no vegetation or obstructions of any sort in channel. <i>Constructed</i> , October, 1915. (Pl. 6, C and fig. 5, A.)
Feb. 26, 1916	7.7	51.0	614.3	328.4	1.87	5.76	0.000094	0.026	
Feb. 10, 1916	8.9	52.4	798.2	390.0	2.04	6.50	.000094	.025	
Mar. 29, 1916	9.5	53.4	919.4	421.8	2.18	6.84	.000096	.025	
Apr. 4, 1916	10.3	54.5	1,252.1	465.0	2.70	7.28	.000124	.024

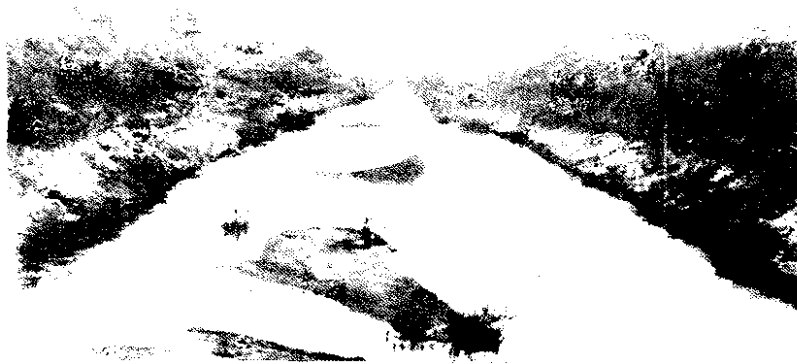
Date of observation	Average maximum depth	Average surface width	Discharge	Average cross section	Mean velocity	Mean hydraulic radius	Slope of water surface	Coefficient of roughness <sup>1</sup>	Description of channel
Aug. 14, 1916	1.2	47.7	41.1	44.6	0.92	0.92	0.000625	0.034	<i>Course</i> , straight; 1,000 feet long. <i>Cross section</i> , slight variations in shape; for variation in size, see fig. 13, D. <i>Side slopes</i> , fairly uniform and regular for lowest three stages; rough and irregular for highest two. <i>Bottom</i> , fairly even and regular. <i>Soil</i> , sand on bottom, clay on sides. <i>Condition</i> , some vegetation in lower part of channel; flat sand bars. <i>Constructed</i> , December, 1912. (Pl. 16, A, and fig. 12, D.)
Nov. 21, 1916	2.2	52.8	131.2	91.4	1.44	1.70	.000478	.032	
Oct. 5, 1916	2.8	53.9	201.4	128.6	1.57	2.25	.000305	.028	
Oct. 28, 1916	5.3	67.2	589.5	285.7	1.99	4.11	.000479	.043

Oct. 29, 1916	6.9	78.1	955.2	397.3	2.40	5.26	.000538	.046	
	10.0								
Sept. 12, 1917	3.2	57.9	290.2	136.9	2.12	2.33	0.000406	0.024	Condition of channel, about the same as for the 1916 measurements. For variation in size of channel see fig. 13, E.
Oct. 19, 1917	4.7	67.6	533.2	254.9	2.27	3.41	.000407	.030	
Sept. 27, 1917	5.1	68.9	577.2	260.0	2.22	3.68	.000416	.033	
Sept. 25, 1917	5.7	71.3	712.5	307.1	2.32	4.18	.000571	.040

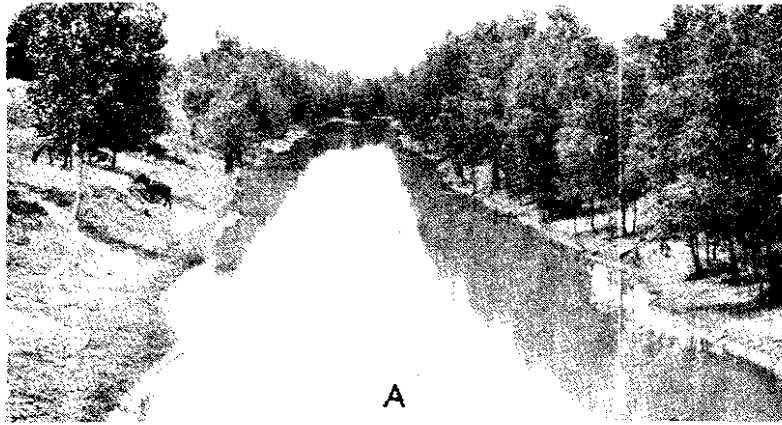
Date of observation	Average maximum depth	Average surface width	Discharge	Average cross section	Mean velocity	Mean hydraulic radius	Slope of water surface	Coefficient of roughness $n$	Description of channel
May 13, 1925	8.0	98.9	447.1	548.5	0.82	5.39	0.0000281	0.032	Course, straight; 1,600, feet long. Cross section, some variation in shape; for variation in size, see fig. 15, C. Side slopes, irregular. Bottom, rather irregular. Soil, upper, clay and sandy loam; lower, silty clay. Condition, some silting in channel; thick growth of willows and cottonwood trees cover most of left bank and about half of right bank; very little undergrowth, due to pasturing; grass on slopes; lower part of channel comparatively free from vegetation, except for some willows on small islands near upper end of course. Constructed, February, 1918. (Pl. 18, A and fig. 14, C.)
May 12, 1925	8.3	100.2	686.3	577.6	1.19	5.60	.0090597	.033
