**GUIDE**  
**FOR**  
**SELECTING ROUGHNESS COEFFICIENT**  
**"n" VALUES FOR CHANNELS**

Compiled by  
Guy B. Fasken, Drainage Engineer  
SOIL CONSERVATION SERVICE - U. S. D. A.  
Lincoln, Nebraska 68508  
December 1963

The purpose of this group of pictures, selected from Technical Bulletin No. 129, "Flow of Water in Drainage Channels" by C. E. Ramser, is to illustrate the wide range of the roughness coefficient "n" of Manning's formula for channel velocities related to actual channel conditions. Study of the pictures and information shown should assist in selecting realistic values of "n" for both present and future constructed channels.

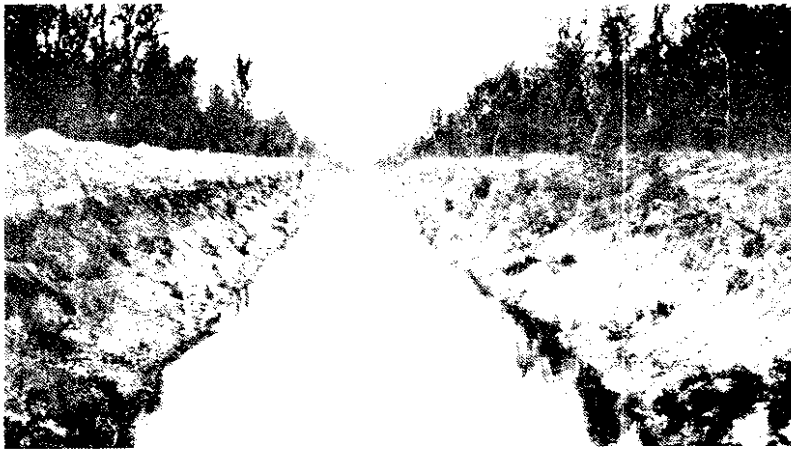
Date of observation	Average maximum depth	Average surface width	Discharge	Average cross section	Mean velocity	Mean hydraulic radius	Slope of water surface	Coefficient of roughness $n$	Description of channel
Jan. 14, 1915	Feet 4.20	Feet 57.5	Second-foot 468.5	Sq. ft. 192.0	Ft. per sec. 2.44	Feet 3.11	0.000297	0.022	Course, straight; 1,003 feet long. Cross section, very little variation in shape; for variation in size, see fig. 4, A. Side slopes, left side, quite regular; right side, fairly regular. Bottom, smooth and even. Soil, lower part, sandy clay loam; upper part, clay loam of close texture. Condition, excellent, very little vegetation of any sort; lower part of channel more uniform and regular than upper part. Constructed, May, 1913. (Pl. 3, A and fig. 3, A.)
Feb. 13, 1915	6.20	63.3	678.4	320.0	2.12	4.61	.000159	.025	
Feb. 11, 1915	8.05	68.5	906.4	440.0	2.06	5.79	.000132	.028	
Feb. 10, 1915	9.45	72.5	1,102.1	535.0	2.06	6.65	.000118	.029

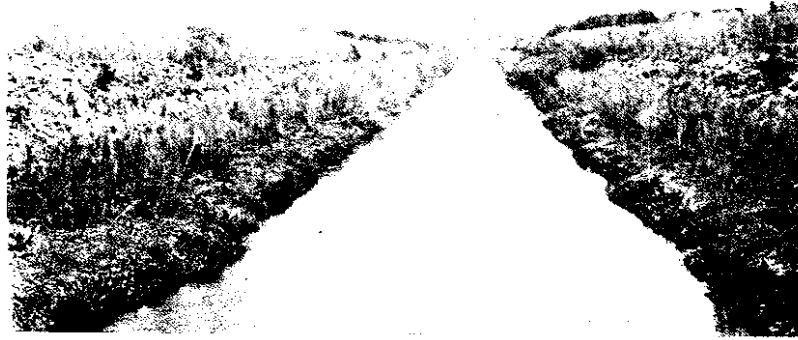
Date of observation	Average maximum depth	Average surface width	Discharge	Average cross section	Mean velocity	Mean hydraulic radius	Slope of water surface	Coefficient of roughness $n$	Description of channel
	<i>Feet</i>	<i>Feet</i>	<i>Second-feet</i>	<i>Sq. ft.</i>	<i>Ft. per sec.</i>	<i>Feet</i>			
Oct. 12, 1916	1.40	45.5	48.8	48.2	1.01	1.05	0.000328	0.025	<i>Course, straight; 2,000 feet long. Cross section, slight variations in shape; for variation in size, see fig. 13, A. Side slopes, lower, fairly regular; upper, rather irregular. Bottom, regular and even. Soil, coarse sand on bottom, clay on sides. Condition, some vegetation, principally dog fennel, for higher stages; practically no vegetation for lower stages. Constructed, November, 1911. (Pl. 15, A.)</i>
Dec. 5, 1916	1.7	46.4	64.7	63.1	1.02	1.32	.000260	.026	
Sept. 22, 1916	5.6	75.6	506.2	298.0	1.70	3.83	.000222	.032	
do.	5.7	78.5	534.0	302.2	1.77	3.83	.000198	.029

do.	5.75	76.5	558.6	314.8	1.77	3.97	.000205	.030	
	15.9								
Feb. 10, 1917	1.6	45.6	44.2	48.1	0.92	1.05	0.000259	0.025	<i>Condition of channel practically the same as during the 1916 measurements. For variation in size of channel see fig. 13, B. See fig. 12, B, for cross section.</i>
July 12, 1917	2.3	49.3	94.7	83.1	1.14	1.66	.000235	.027	
Oct. 18, 1917	3.2	53.5	186.4	127.7	1.46	2.33	.000238	.027	
Sept. 29, 1917	5.0	68.8	403.1	241.4	1.67	3.15	.000200	.027	
do.	7.6	88.5	746.8	441.9	1.69	4.86	.000185	.036

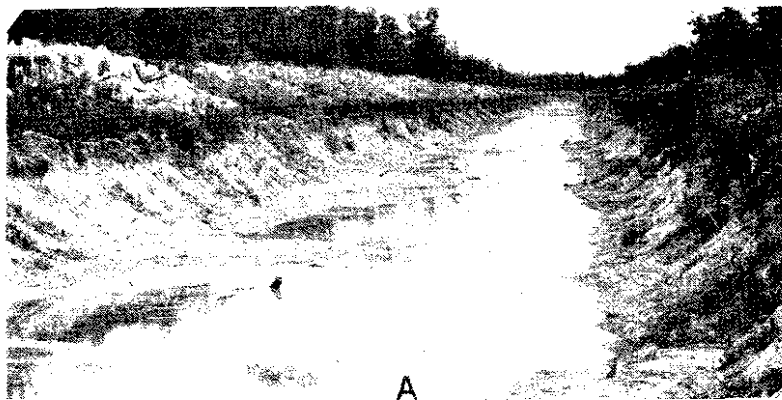
Date of observation	Average maximum depth	Average surface width	Discharge	Average cross section	Mean velocity	Mean hydraulic radius	Slope of water surface	Coefficient of roughness $n$	Description of channel
	<i>Feet</i>	<i>Feet</i>	<i>Second-feet</i>	<i>Sq. ft.</i>	<i>Ft. per sec.</i>	<i>Feet</i>			
May 3, 1926	4.1	68.2	150.7	206.5	0.73	2.92	0.000630	0.032	<i>Course, straight; 1,710 feet long. Cross section, not much variation in shape; for variation in size, see fig. 15, A. Side slopes, somewhat irregular. Bottom, rather irregular and uneven. Soil, heavy silty clay. Condition, practically no vegetation or obstructions in channel; newly dredged. Constructed, September, 1924. (Pl. 17, A and fig. 14, A.)</i>
Feb. 19, 1926	4.7	70.4	250.1	230.6	1.00	3.42	.000587	.030	
May 11, 1926	6.0	74.4	371.2	336.2	1.10	4.34	.000708	.031	
Mar. 7, 1926	9.9	85.0	1,178.2	660.0	1.78	7.18	.000824	.030	
Jan. 26, 1926	10.1	85.1	900.6	670.2	1.34	7.27	.000555	.034

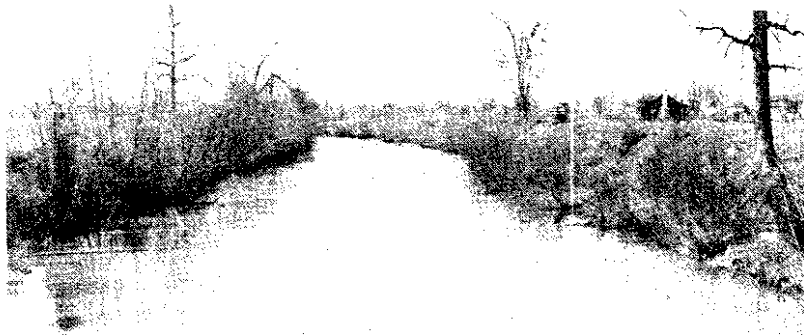
Date of observation	Average maximum depth	Average surface width	Discharge	Average cross section	Mean velocity	Mean hydraulic radius	Slope of water surface	Coefficient of roughness $n$	Description of channel
Mar. 15, 1926	8.8	121	944	756	1.25	6.09	0.00072	0.036	<i>Course</i> , nearly straight, slight curve at lower end; 1,554 feet long. <i>Cross section</i> , very little variation in shape; for variation in size, see fig. 4, B. <i>Side slopes</i> , very irregular. <i>Bottom</i> , irregular and uneven. <i>Soil</i> , clay loam, sandy bottom. <i>Condition</i> , weeds and small trees along banks; natural channel; was cleaned of all growth and obstructions in 1915. (Pl. 3, B and fig. 3, B.)
Nov. 17, 1925	10.4	132	1,050	965	1.12	7.10	.00056	.041	
Mar. 7, 1926	11.8	142	2,867	1,157	2.45	7.92	.00214	.037	
Mar. 9, 1926	12.5	147	2,383	1,260	1.89	8.32	.00106	.036	
Jan. 22, 1926	12.8	150	2,875	1,310	2.19	8.51	.00139	.036

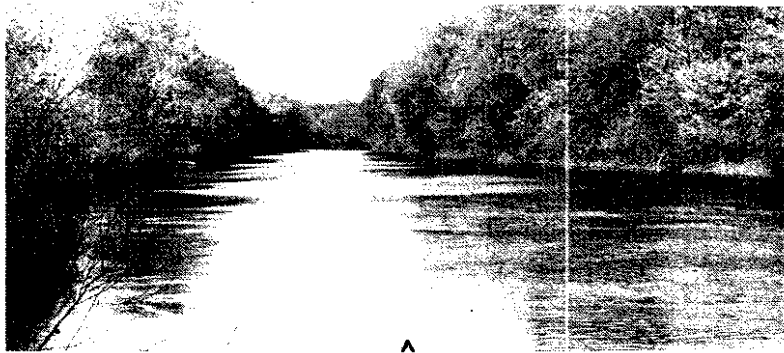
Date of observation	Average maximum depth	Average surface width	Discharge	Average cross section	Mean velocity	Mean hydraulic radius	Slope of water surface	Coefficient of roughness $n$	Description of channel
	<i>Feet</i>	<i>Feet</i>	<i>Second-foot</i>	<i>Sq. ft.</i>	<i>Ft. per sec.</i>	<i>Feet</i>			
Apr. 13, 1926	8.7	139.3	1,974.9	945.3	2.09	6.52	0.000136	0.030	<i>Course</i> , straight; 1,000 feet long. <i>Cross section</i> , very little variation in shape; for variation in size, see fig. 20, A. <i>Side slopes</i> , somewhat irregular. <i>Bottom</i> , fairly even and regular. <i>Soil</i> , lower part, light gray silty clay; upper part, light tan silt loam. <i>Condition</i> , bottom comparatively clean and smooth, upper part of side slopes covered with large trees; natural channel. (Pl. 24, A and fig. 19, A.)
Feb. 27, 1926	9.9	146.4	2,500.7	1,119.2	2.23	7.32	.000128	.031	
Apr. 10, 1926	13.5	180.0	4,265.4	1,700.1	2.51	9.04	.000128	.032

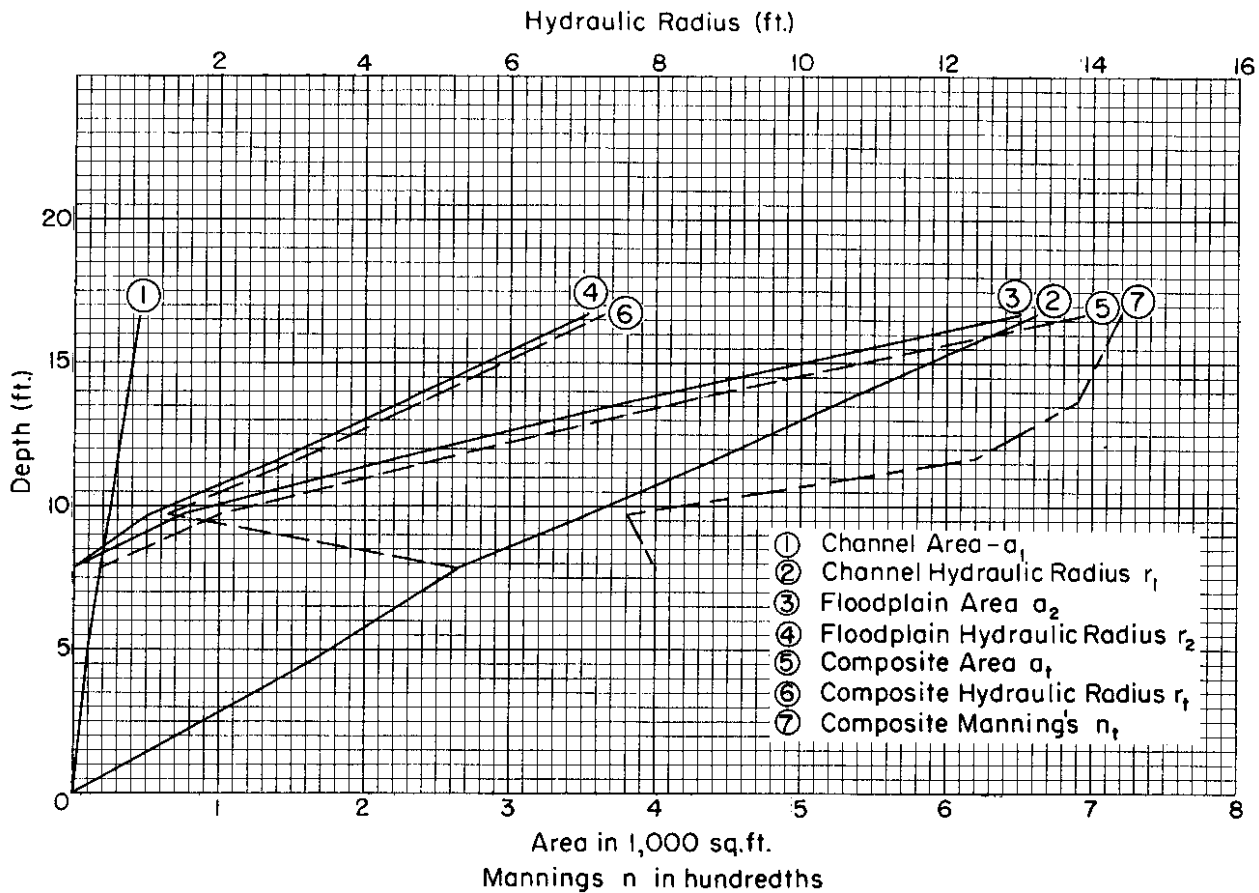
Figure B.3

1. An actual stream cross section for which curves showing depth versus area and depth versus hydraulic radius for the channel and flood plain subdivisions and for the complete section are plotted on Figure B.3. Values of n are: for the channel subdivision 0.04; for the flood plain subdivision 0.08.
2. The conditions of uniform, steady flow are assumed.

This example also illustrates that recognition of high retardance for flood plain subdivisions by the use of relatively high  $n$  values does not cause  $n$  for the complete section,  $n_t$ , to be unreasonably high. In this case, the channel and flood plain are assigned  $n$  values of 0.04 and 0.08. The value of  $n_t$  ranges up to 0.072 as shown by Table B.2 and Figure B.3.
